SAFETY RECALL

October 2011

A small number of 2012 Trek bicycles were made with a saddle clamp bolt, on the seat post, that exhibits hydrogen embrittlement. This is a list of the affected models:

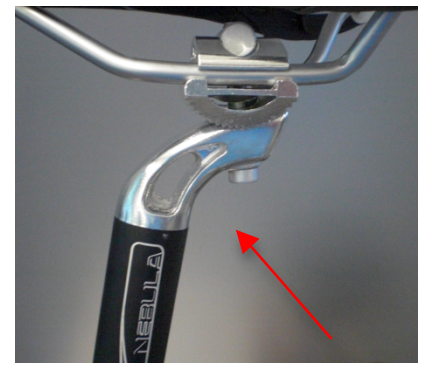
Hydrogen embrittlement could allow the saddle clamp bolt to break, which could allow the saddle to come off the seat post unexpectedly. If this happens, the rider could fall and possibly be injured. Your safety is very important to us. Therefore, Trek will replace the saddle clamp bolt on an affected bicycle, free of charge.

Figure 1. Nebula seatpost showing saddle clamp bolt

If you own a bicycle that is affected by this recall, Trek will provide you—through your Trek dealer—a free replacement of the saddle clamp bolt on your bicycle. If you have any questions, please contact your dealer, or call Trek at the special recall hotline:
